# Report of the Auditor General on the Road Projects Under the

## Road Development Agency (RDA)

for the Period  
January 2012 to December 2015

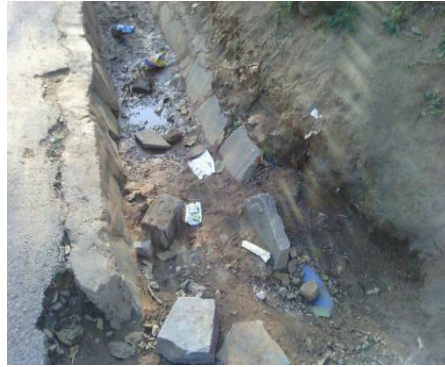
*Drainage structure on Chipata 1 road without a concrete lined base (Lot 8 B11)*

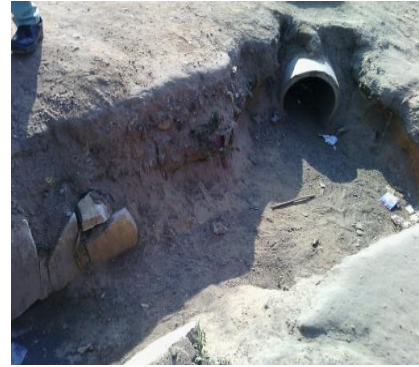
*Incomplete works with stones falling off at Chipata 1 road (Lot 8 B11)*

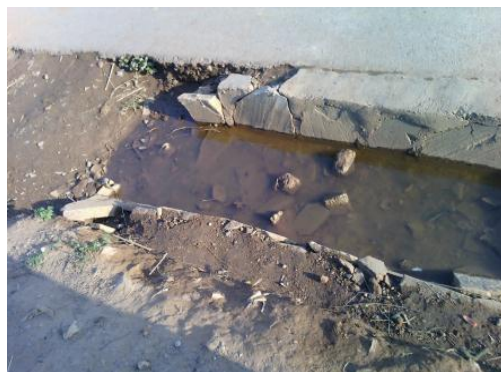
*Lack of access for continuous flow of water along Chipata 2 road (Lot 8 B11)*

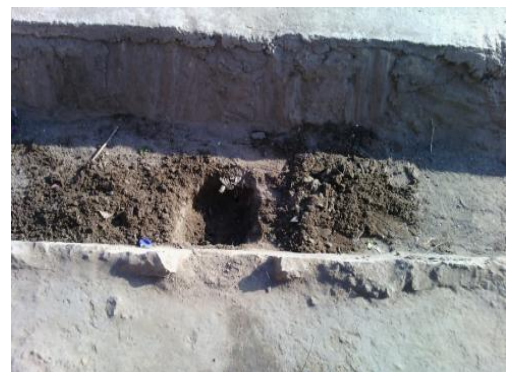
*Drainage without a lined base along Chipata 2 road (Lot 8 B11)*

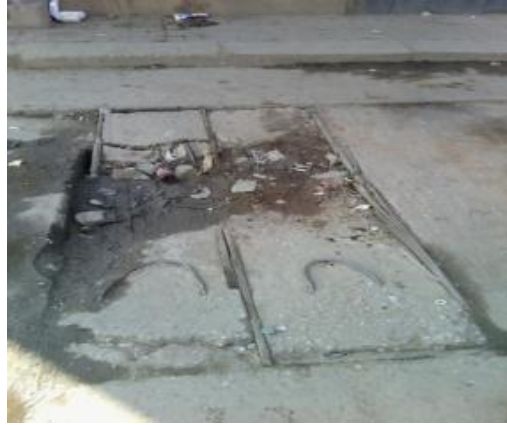
*Installed concrete slabs breaking up on drainages along Chozi Road installed concrete slabs wearing out with Y10 bars showing (Lot 8 A5)*

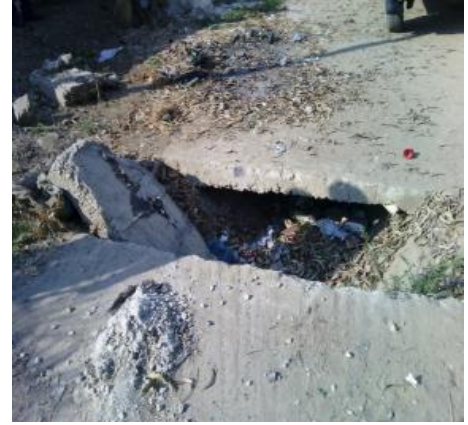
*Parts of concrete slabs installed along Chozi Road had broken (Lot 8 A5)*

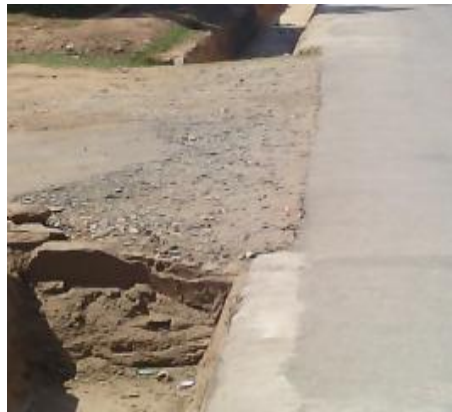
*Stalilo drainages in Kaunda square*

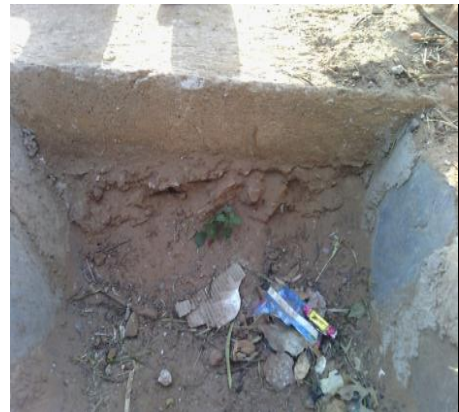
*Drainage with dead end as there was no provision of access to private property (Lot 8 B11)*

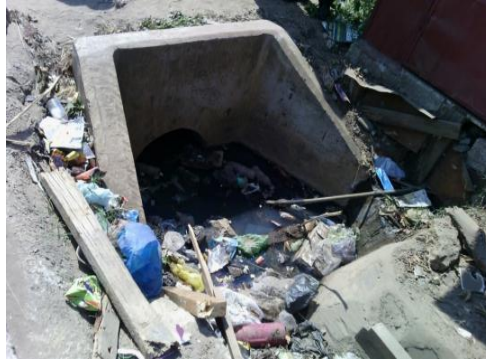
- improperly constructed culvert as one end of the culvert did not have an outlet at the junction of Chiyuni Mazamba and Sikwaze road (Lot 7 A1)

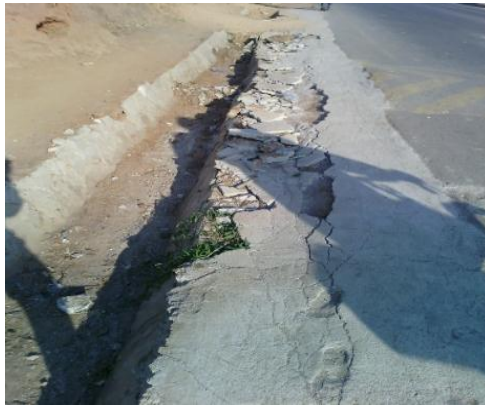
*Constructed shoulders and walk way without conforce wire breaking up along Chipata 1 road (Lot 8 B11)*

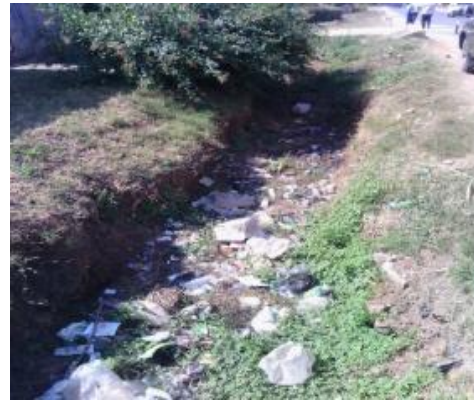
*A section of the road measuring thirty (30) metres had no stone pitch on Ngwerere road in Chelson Square pitch (Lot 7 A4)*

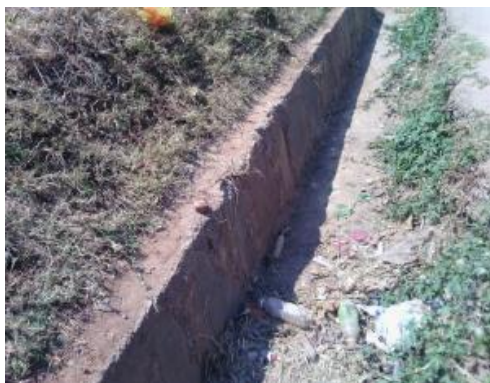
*Incomplete Drainage structure (Lot 7 A4) Structure stone pitched on one side(Lot 7 A4)*

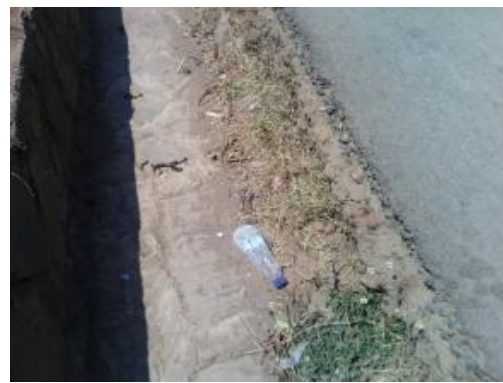
*Unpitched walls of drainage (Lot 7 A4)*

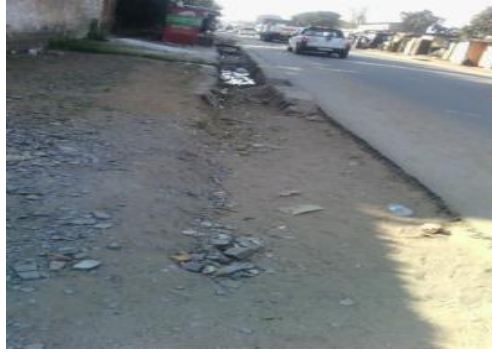
*Incomplete/abandoned drainage works along Mutendere road (Lot 7 A3)*

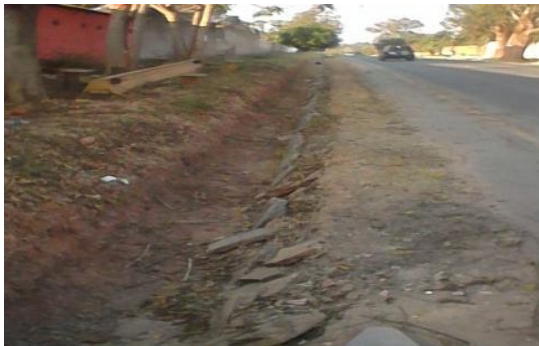
*Incomplete Drainage Structure in Chudleigh due to Inadequate BOQ Materials (Lot 8 B10)*

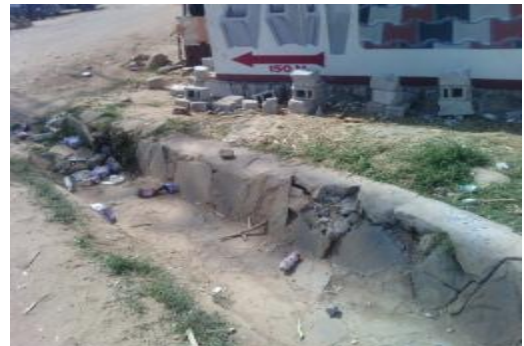
*Broken Drainage structure at the Mutumbi Curve (Lot 7 A3)*

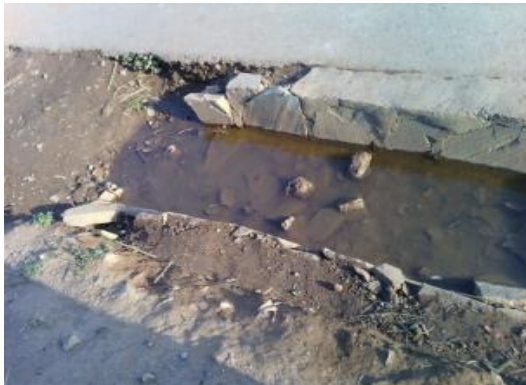
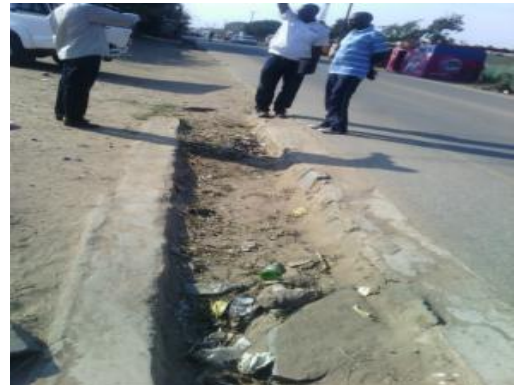
*Uncompleted works with drainage which had no direction of discharge flow (Lot 7 A3)*

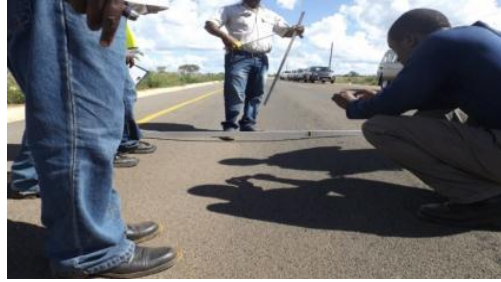
when measured under a 3m Straight Edge which was an indication that the road base had failed.

*Surface Irregularity at 34mm on the average cross section on road No. 1 in MFEZ area*

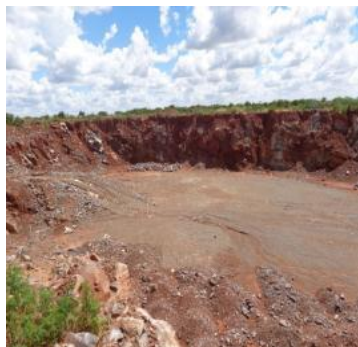
However, despite breaching of this condition, RDA granted BICON/CHINA JIANGXI the substantial completion certificate in 2014 with a borrow pit and quarry not reinstated. See pictures below.

*Unburied quarry for stone aggregate*

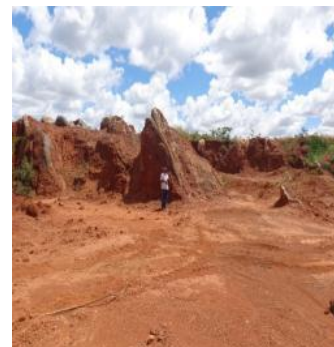
*Unburied borrow pit for gravel*

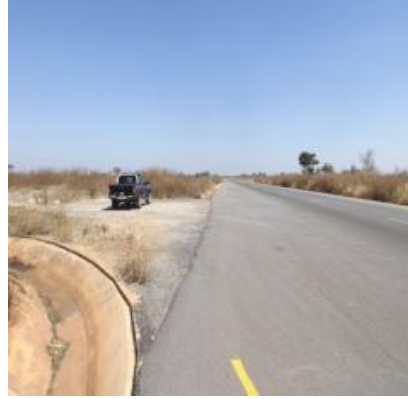
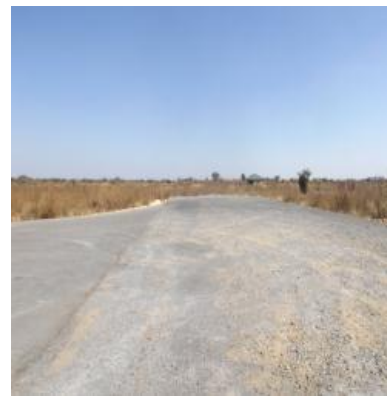
It was observed that the five (5) bell mouths which were reported in the 2012/2013 snag list had not been surfaced as of October 2016. See picture below.

*Bell mouths not surfaced at the road edge within MFEZs*

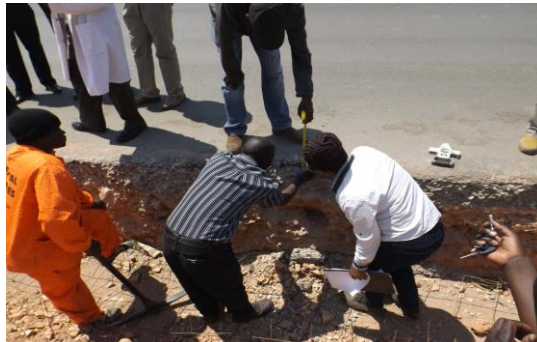
- At Km 0+000, the maximum base thickness measured was 105 mm on RHS shoulder; required base thickness is 150 mm.
- At Km 0+104, the maximum base thickness measured was 100 mm on LHS shoulder; required base thickness is 150 mm.

*Measurement of the base*

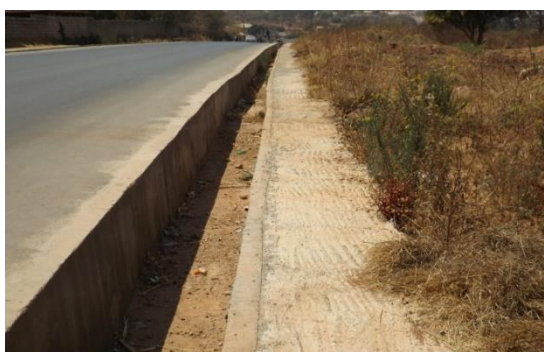
- 35 m section of walkway was rejected as it was of poor quality, and
- The walkway has bad aesthetics and no expansion joints. See picture on the next page.

*The walkway with bad aesthetics and no expansion joints*

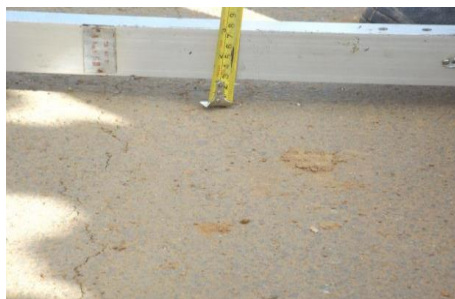
At Km 13+900 to 14+300 LHS, the average cross section surface irregularity was 27 mm when measured under a 3 m Straight Edge contrary to the required maximum of 10 mm under Clause 4212 Construction Tolerances and Finish Requirements in SATCC specification. The length of the section with this defect was 312 m at the MFEZ entrance connected to the ring road. The Rutting indicates the road base has completely failed.

*Irregular surface*

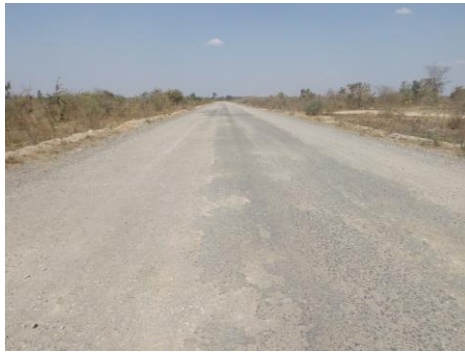
There were crushed stone base surface irregularities due to ravelling in that the stone base had not been protected contrary to SATCC clause 3404. See picture below.

*Worn out crushed stone base not protected with quarry dust from weather elements and traffic*

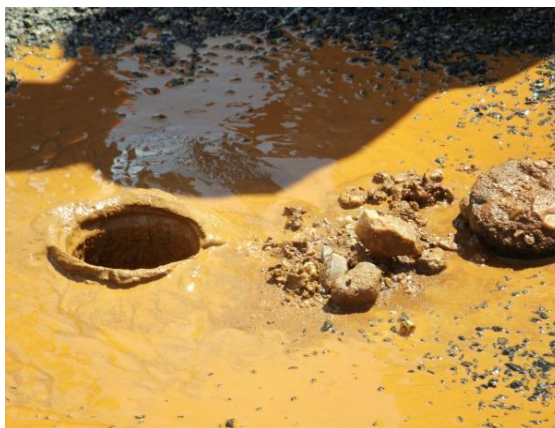
- At Km 0+000 LHS, the drilled core crumbled.

*Crumbled core*

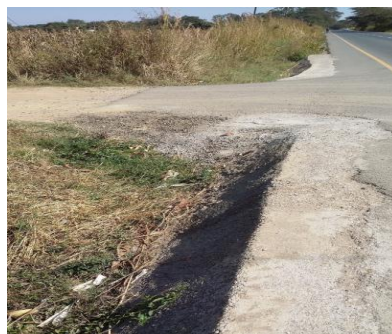
- Sharp Curves – Barlastone Park Road: at chainage 00+700, there were junctions which were turned into curves and at some of the curves, there were contradicting signs for curving to the right and a stop sign. Some of these curves were within a 100 M of each other thereby increasing accident risks.
- Bellmouth constructed without a culvert thus blocking drainage at access points as shown in the picture below.

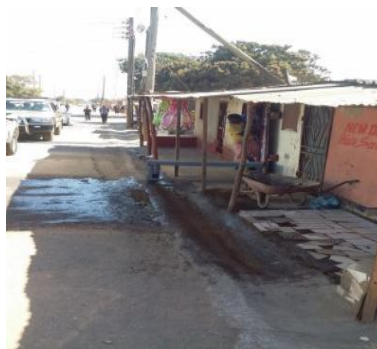
Contrary to the requirement of the Public Roads Act, there were properties within 9 metres of the road centerline in most areas. In particular, it was observed that on the MA 033 - Kamanga – Mutumbi Road there were ZESCO poles in the drainage and private shops within the road reserves as shown in the picture below.

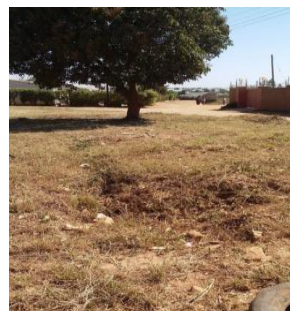
On Road NA 35 in Chelston, a stretch of about 245 m was not upgraded because the purported owner of the piece of land where the road was designed to go through had refused RDA to construct the Road. However, there was no evidence that RDA had verified ownership of the plot with the Lusaka City Council or the Ministry of Lands. See picture below.

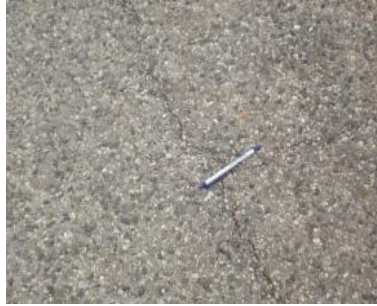
No sealing of the crack had been undertaken as per SATCC clause 4907.

*Reflective Cracking on the road surface.*

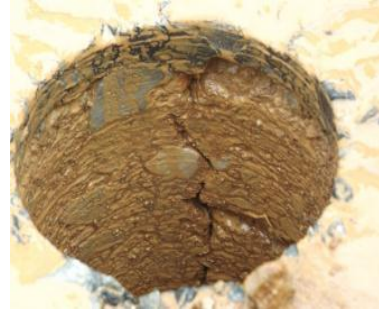
*Evidence of reflective cracking going through the base.*

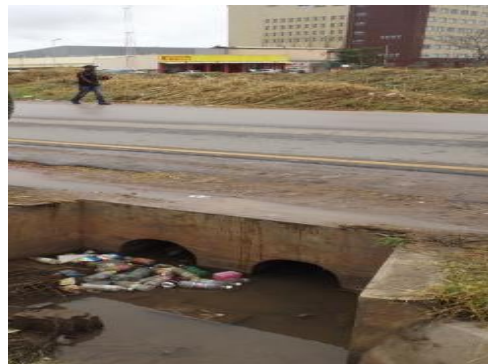
The drainage system did not have an outlet for the storm water leading to ponding at the entrance to the Showground.

*The NASDEC Road had a drainage system that did not have an outlet for the storm water leading to ponding at the entrance to the Showground*

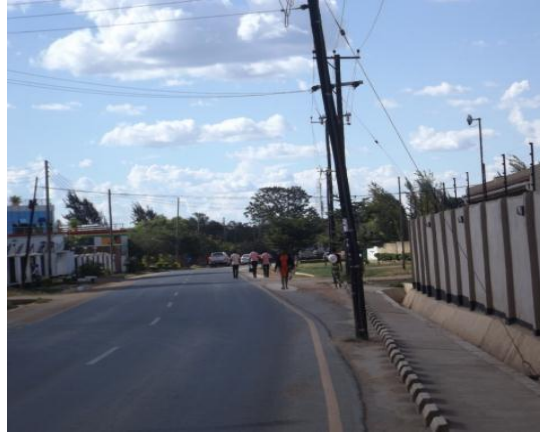
The electricity poles near Football House were less than 1 metre from the edge of the carriage way contrary to SATCC Geometric standard 5.8.

*Electricity poles less than 1 metre from the edge of the carriage way*

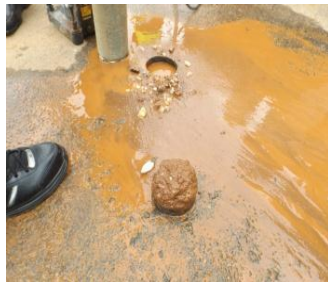
The maximum core thickness retrieved was 50 mm. For the trial pit on stabilised base thickness of 110 mm was measured. The variation was well out of the accepted tolerance of 27 mm for the base course implying that the least thickness that can be accepted is 123 mm.

*A core on Nkholoma Stadium road retrieved with a stabilised base thickness of 50mm contrary to the required 150mm.*

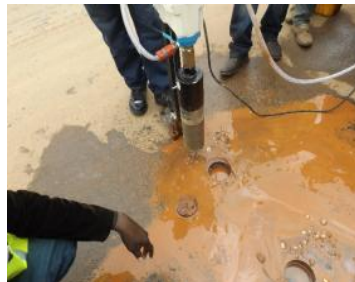
*A core on Nkholoma Stadium road retrieved without any Base Material*

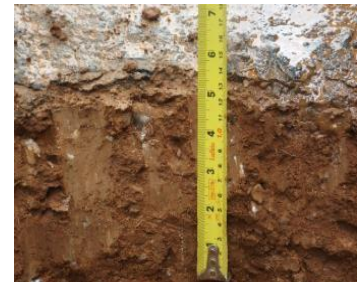
*A trial pit on Nkholoma Stadium Road with a stabilised base thickness of 110mm.*

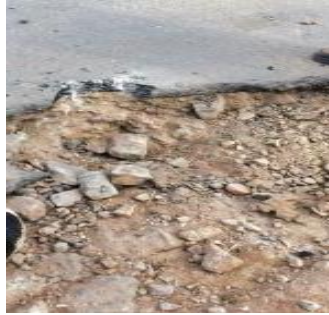
road base while the specification required a crushed stone base of 150 mm. See picture below.

*Existing mine waste rock road base  
used as opposed to crushed stone base*

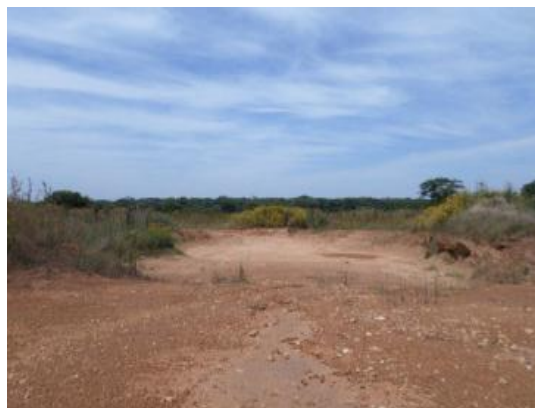
During the physical inspection of the road in May 2015, it was observed that the borrow pits were not reinstated despite the project having been completed in April 2014. A follow up visit in October 2016 revealed that the situation had not changed. See picture below.

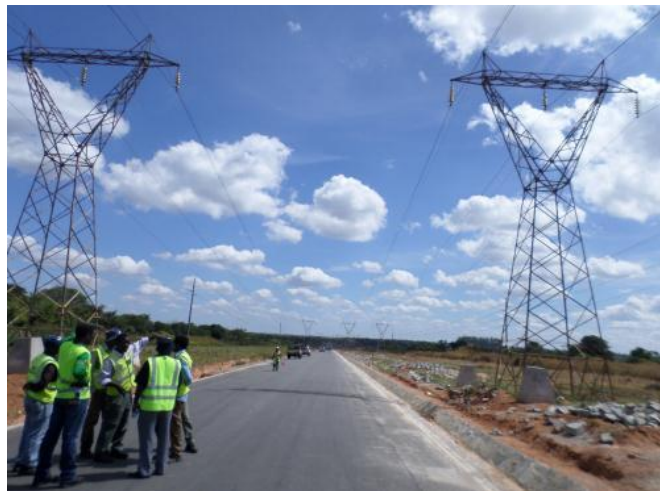
A physical inspection of the road carried out in May 2015 revealed that a section of 1.8 km of the road was constructed between two 66KV electricity transmission lines which were less than 18 meters from the road centre-line contrary to the Public Roads Act Section 21, subsection (2) which defines the width of the road reserve for each class of roads. See picture on the next page.

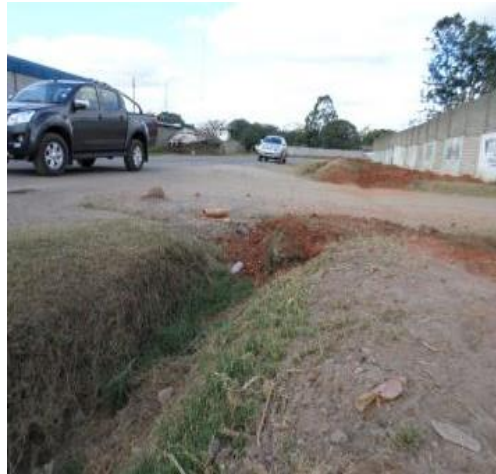
- A physical inspection of the Industrial Road at the Olympic Milling Company entrance conducted in June 2015 revealed that there was no access into the company due to inadequate design, and the consultant reported that there were no quantities for culverts at the Olympic Milling Company in the contract.
- A second physical inspection of the same road conducted in September 2016 revealed that the access culverts had not been constructed.

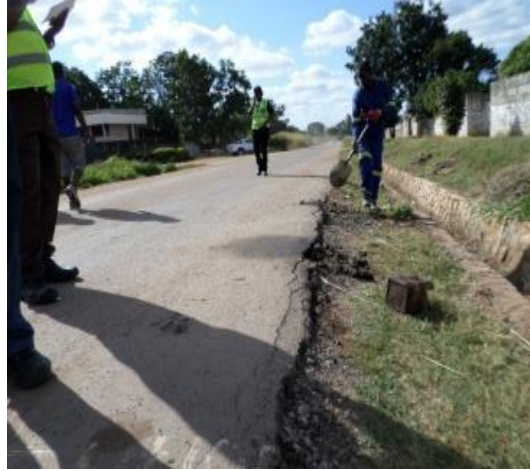
- On the Chipulukusu Road, there was inadequate designs on the Railway Crossing in that there were no concrete approaches used which are more resistant to slow moving heavy loads.
- To protect the carriageway from edge breaks as motor vehicles move off the road, there must not be a step change into the shoulder. However, it was observed that the shoulders were not worked on and raised to the

level of the carriageway and as a result, there were edge breaks observed as shown in the picture below.

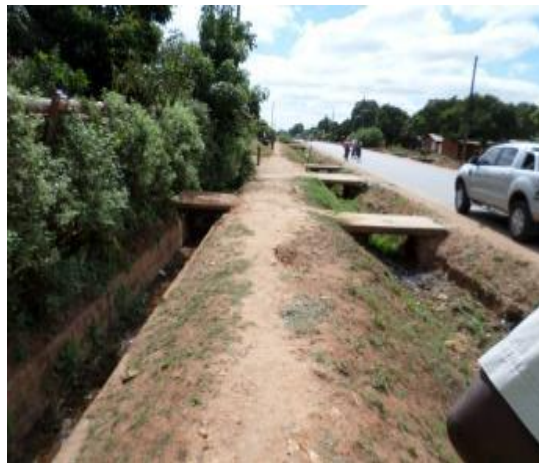
- It was also observed that some sections of the road to Chipulukusu had old lined drainage which was ignored during the new construction of the road as it ran parallel to the new unlined drainage as shown in the picture below.

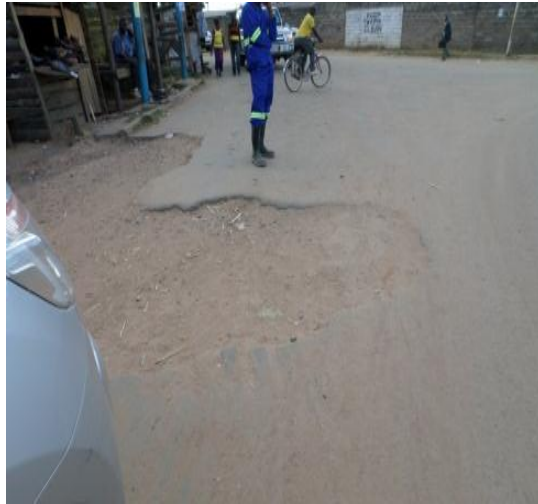
A physical inspection of the Lubuto - Twapia road at chainage 3 +960 at Twapia Market revealed that potholes had already developed on the new road as shown in the picture below.

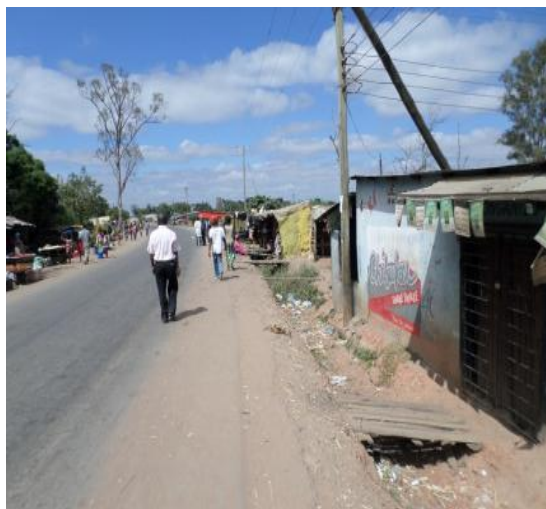
Contrary to the Public Roads Act 2002 which provides for the minimum road reserve of 9m either side from the centre-line, there were structures within 1 m to 2 m on either side of the road as shown in the pictures below.

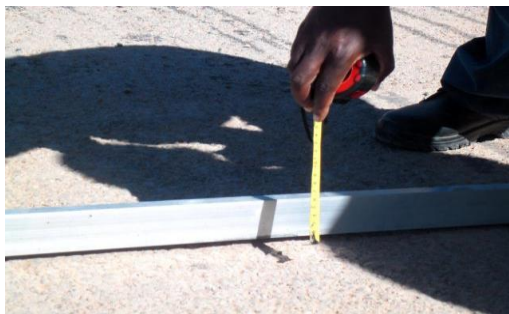
- At Km 0+675 RHS, the average rutting measured was 12mm. see picture below.

*Visual inspection of rutting or surface regularity*

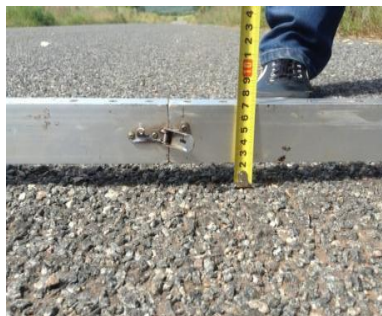
*Surface Irregularity on the road*

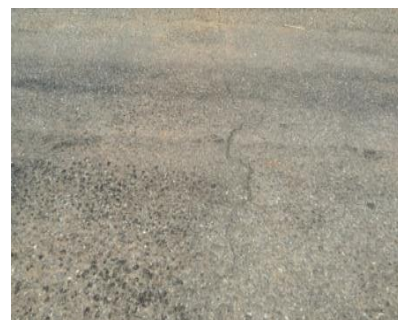
It was further observed that there were notable visible cracks on the road surface. However, no remedial works were undertaken as of December 2016. See picture below.

*Cracks on the newly constructed road*

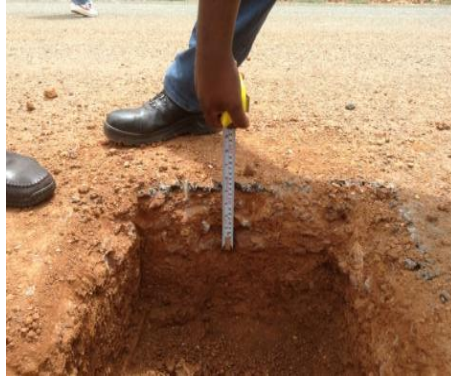
- At Km 46+600, core crumbled. In the trial pit the base was measured to be 130mm thick, and
- At Km 49+500, core crumbled. In the trial pit the base was measured to be 155mm thick.

There were no remedial works undertaken as of December 2016 as required under SATCC 1218. See picture below.

*Measurement of base*

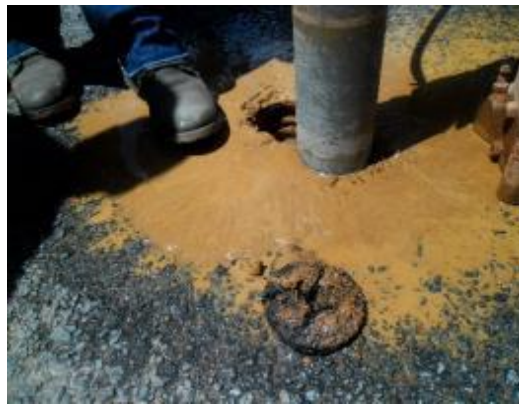
The cores retrieved did not meet the 150 mm thickness or 123 mm minimum thickness as per SATCC clauses 3405 and 7205

*Crumbled cores*

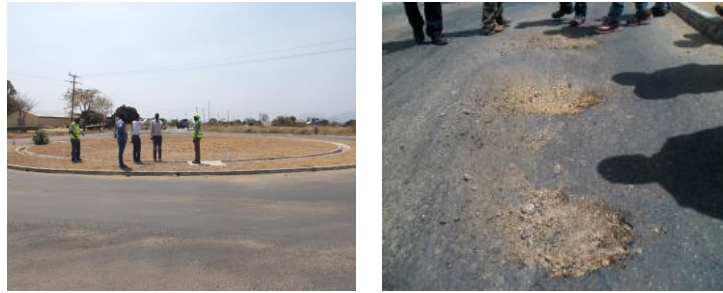
- The road markings were faded,
- There were no road signs for humps,
- The drainage pipe of 200 mm was too small for self-cleansing and maintenance at the roundabout, and
- Some cracks have been sealed and a core drilled on a crack revealed that the cracks were propagating through the base.

*Potholes and rutting at the roundabout has not yet been repaired.*

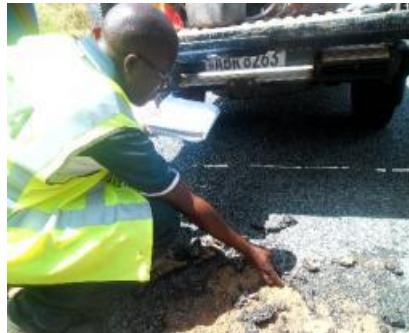
- There was a visibly poorly constructed joint for 600 mm.
- The road surfacing was peeling away due to poor adhesion of the road surfacing and road base.

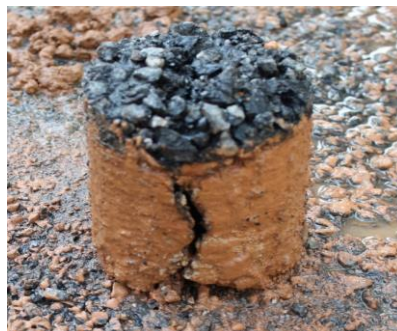
- Cracks were observed to be within 2 m from the edge on both sides of the edge,
- Some cracks had been sealed and a core drilled on the crack revealed that the crack was propagating through the base

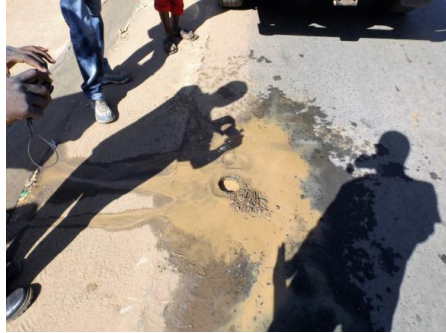
- At Km 0+000 LHS, no core retrieved. Core crumbled
- At Km 0+000 LHS, surface irregularity /rutting under a 3 meter straight edge was measured to be 18mm contrary to the requirements of SATCC 4212
- At Km 0+000 LHS, no core retrieved. Core crumbled

*Crumbled Core*

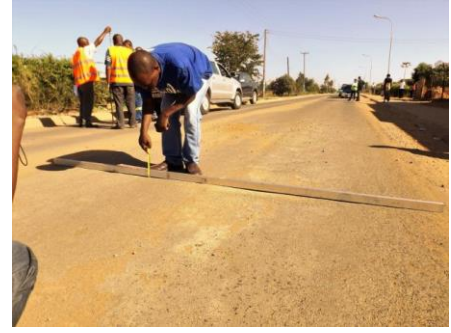
*Rutting of 12mm under a 3m straight Edge*

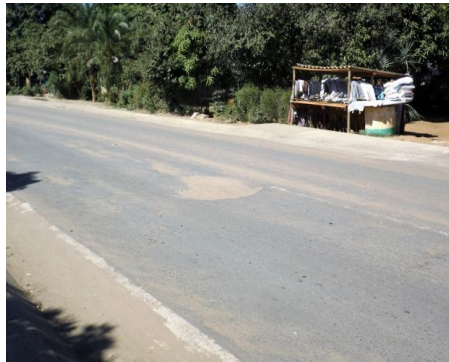
*Area prone to water logging with poor design leading to base failure*

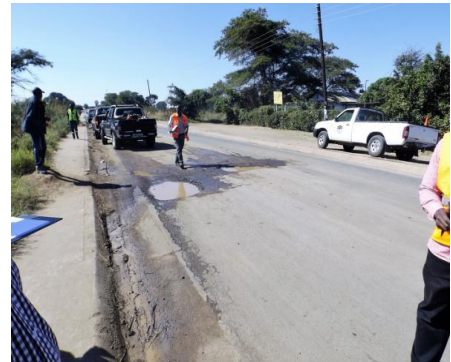
*Poor drainage design*

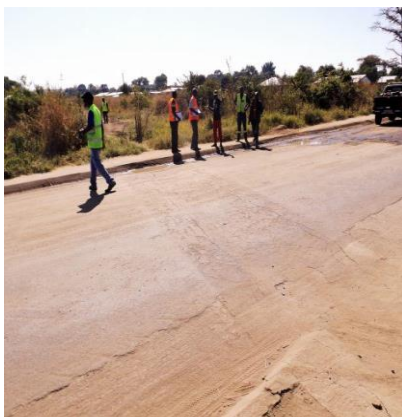
*The concrete on the Dip was poorly designed affecting smaller vehicles, it was repaired unconventionally*

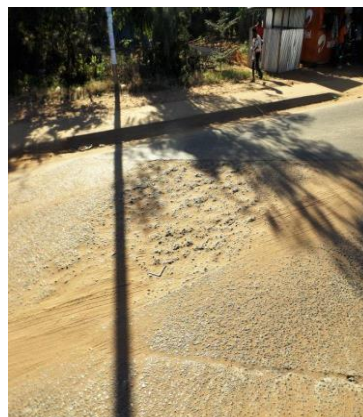
*Area prone to water logging with poor design leading to base failure*

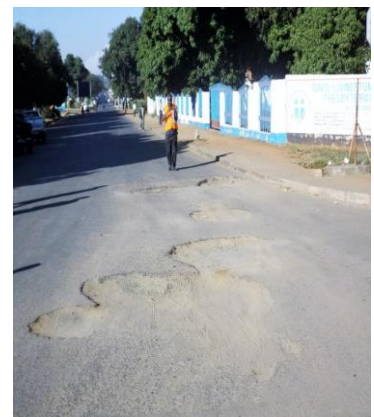
*Area prone to water logging with poor design leading to base failure*

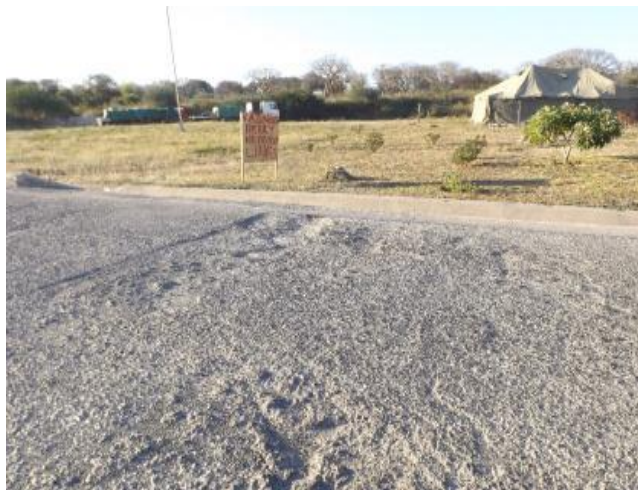
Although the works had been completed and the project was beyond the defect liability period, a physical inspection conducted in May 2015 revealed that the concrete works undertaken were of poor quality and spalling (worn out) resulting into potholes that developed on the carriage way as can be seen below.

*Worn out driving surface at Kazungula Weighbridge*

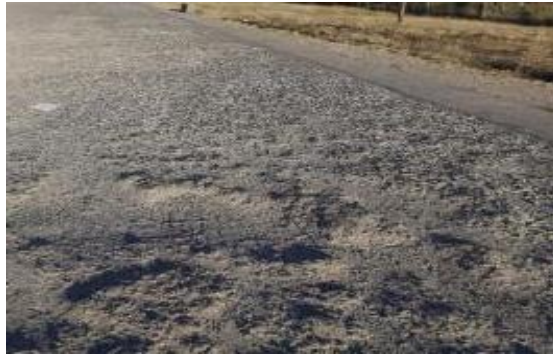
The carriage way on the weigh bridge was reinforced with conforce wire instead of adequate reinforcement bars such as 16 mm reinforcement bars. In general, the design was poor and could not withstand the stress of heavy duty vehicles.

*Poorly constructed carriageway reinforced with conforce wire*

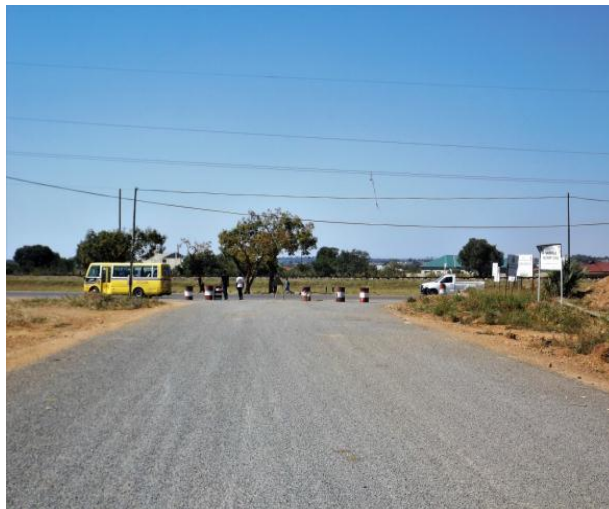
At Km 70+984, the road was constructed under power/communication lines with inadequate height clearance. See picture below.

*Utility cable with low clearance*

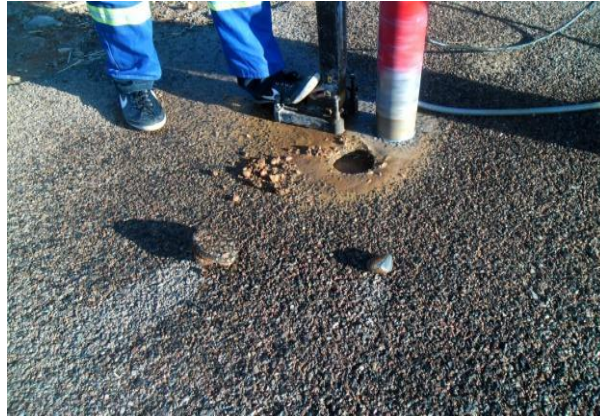
- At Km 130+000 RHS, no core retrieved. The average core thickness retrieved was 0 mm. In the trial pit the base was measured to be 200 mm and subbase thickness was measured to be 0 mm.

*Failed core*

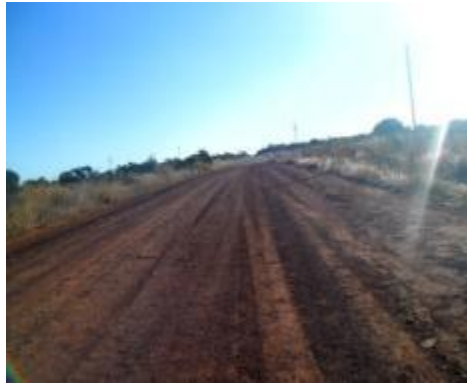
comprising two sections in the dambo areas from Km 7+380 to Km 8+820 and Km 69+020 to Km 72+260 was still un-surfaced more than one year after the tarmac was removed. See picture below.

*Un-surfaced Portion*

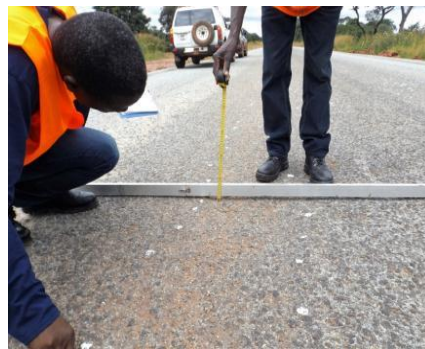
The road was visibly poorly constructed at Km 82+000 RHS showing a depression of 20 mm over a stretch of 400 m and at km 90+125 showing a depression of 30 mm. These were above the requirement of maximum of 10 mm under clause 4212 construction tolerances and finishing requirements in SATCC specification.

*Surface Irregularities observed using a 3 m straight edge*

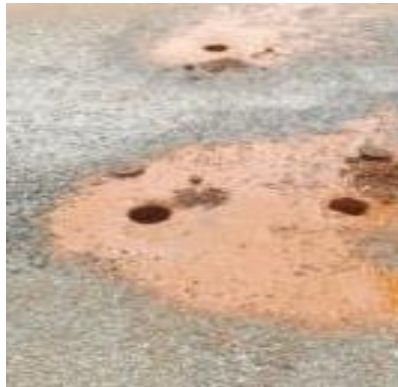
- At Km 93+000 LHS, three (3) cores crumbled. See picture below.

*Crumbled Core*

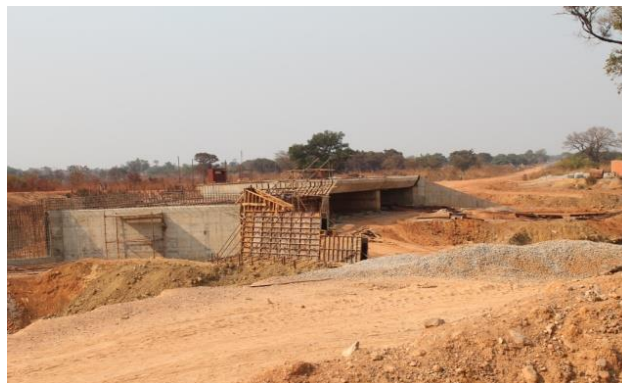
It was further observed during the inspection conducted in September 2016 that the bridge had not been completed as shown in the picture below.

*Bridge still under construction*

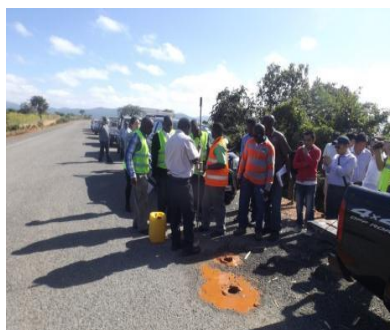
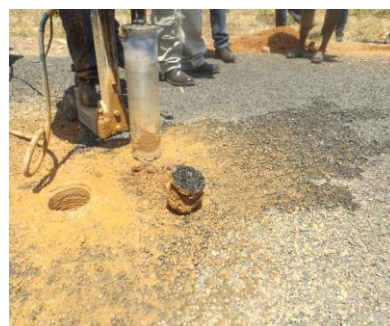
- i. At Km 1+240 LHS, two (2) cores crumbled.
- ii. At Km 2+740 LHS, core retrieved. The average core thickness retrieved was 112 mm.
- iii. At Km4+240 RHS, core retrieved with thickness 85mm and the 2<sup>nd</sup> core drilled by the contractor was 70 mm thick.
- iv. At 6+540 LHS, 1<sup>st</sup> core crumbled thickness 0 and the 2<sup>nd</sup> core retrieved with average thickness of 60 mm.
- v. At 7+740 RHS, 1<sup>st</sup> core crumbled thickness 0 and the 2<sup>nd</sup> core retrieved with average thickness of 125 mm.
- vi. At Km1+800 LHS, no core retrieved. Core crumbled.
- vii. At Km 3+640 RHS, no core retrieved. Core crumbled.
- viii. At Km4+280 LHS, no core retrieved. Core crumbled.

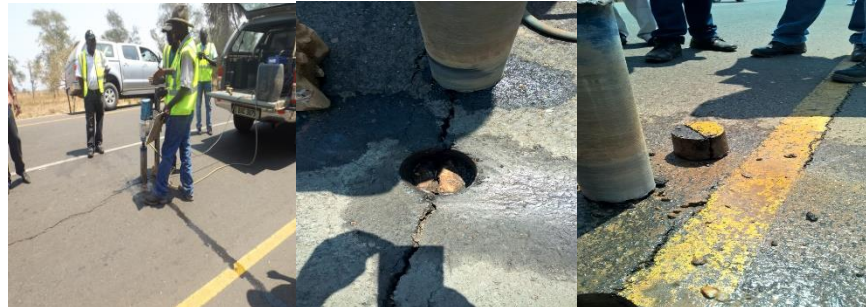
*A core taken on the crack reviewed that the cracks propagated all the way to the base*

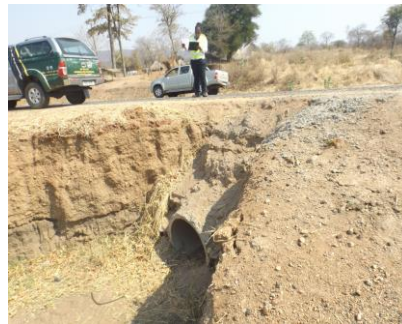
*Culvert without headwalls along the  
Chipata - Mfuwe Road*

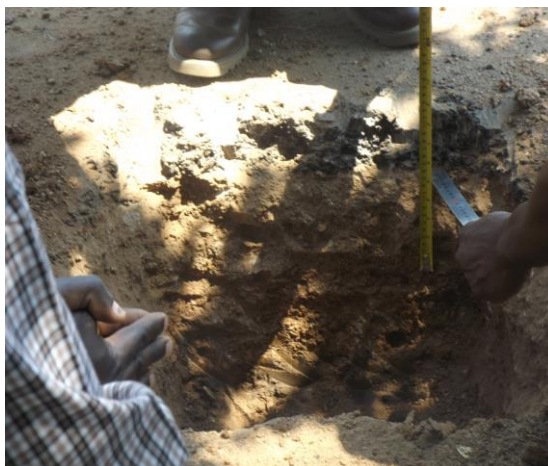
- At Km 16+600 RHS, the base thickness was 140mm from the trial pit.
- At Km 14+400 LHS, the base thickness was 160mm from the trial pit.
- At Km 12+500 RHS, the base thickness was 195mm from the trial pit.
- At Km 10+800 LHS, the base thickness was 190mm from the trial pit.

Two measurements from the trial pit did not meet the 200mm thickness or 173mm minimum thickness as per SATCC clauses 3405 and 7205. See picture on the next page.

*Trial Pit along the road from Mfuwe to the Gate to South*

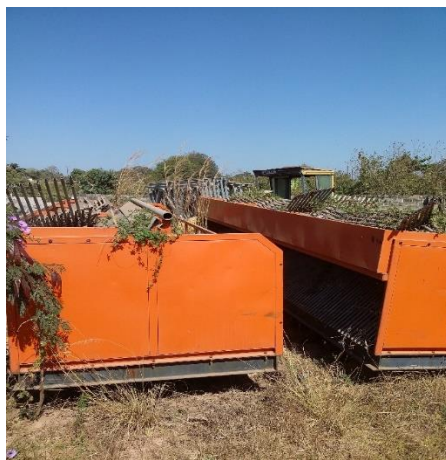
However, a physical inspection of the equipment delivered to the ten (10) RDA Regional offices conducted in June 2016, revealed that the machines had never been used since they were delivered in 2013.

*Parked segmented paving block machines*

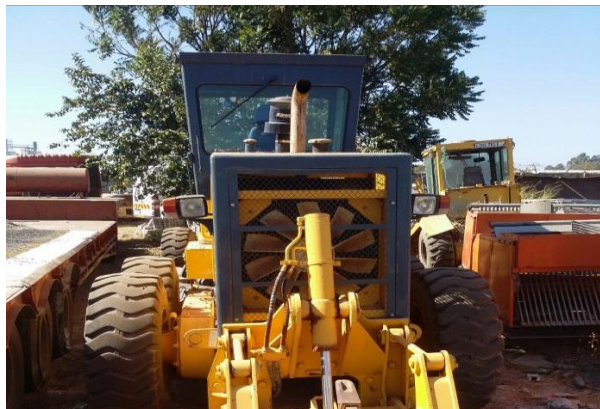
A physical inspection of equipment carried out in June 2016 revealed that contrary to the Road Traffic Act, ten (10) graders at six (6) regional offices had not been registered.

*Unregistered Grader at Ndola RDA*
